Office of the West Virginia Attorney General

Elk River Chemical Spill INCIDENT REPORT

January 8, 2015

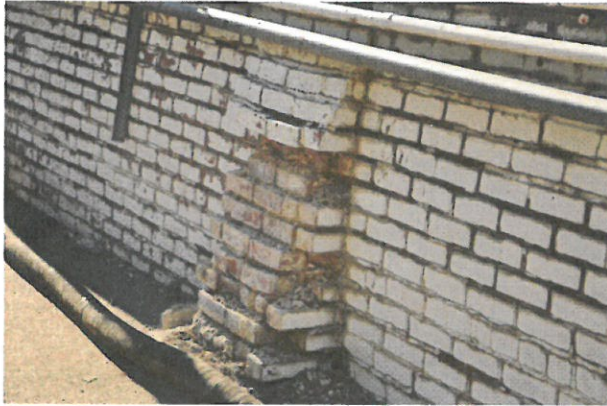
The containment walls were constructed of brick or cinderblock, and were generally topped or covered with concrete.

Containment wall facing Barlow Drive

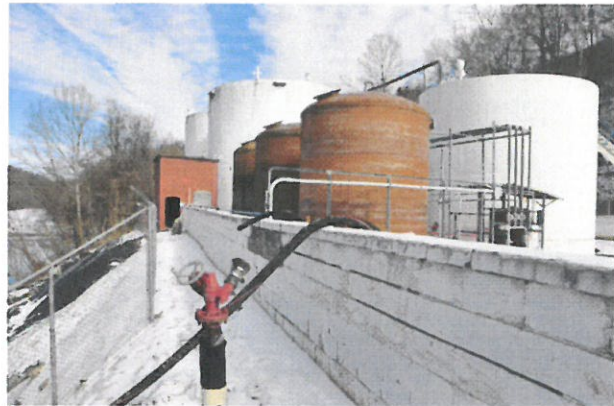
Containment wall facing Elk River

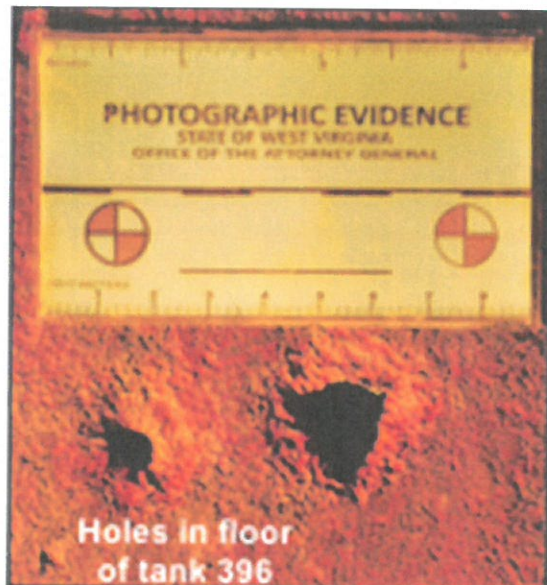
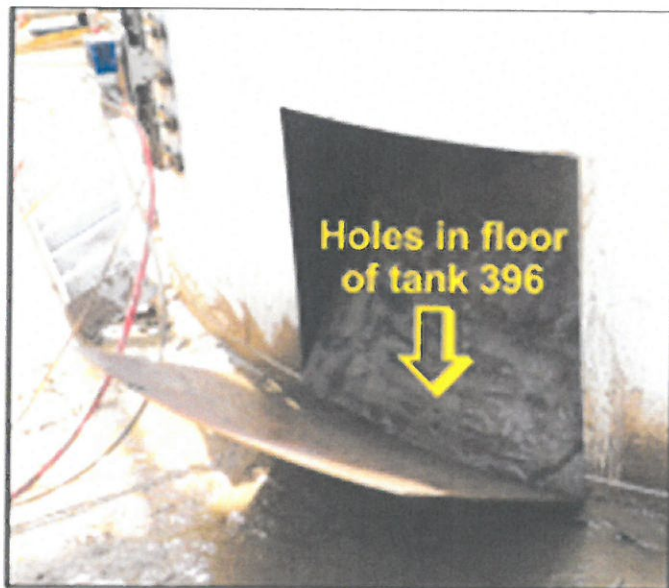
In particular, an inspection of tank 396 revealed that two holes existed on the floor. The first (larger) hole measured approximately $5/8"$ x $21/32"$, while the second (smaller) hole measured approximately $1/4"$ x $9/32"$. The holes in the bottom of the tank are positioned approximately $2\frac{1}{2}$ inches to $4\frac{1}{4}$ inches inside the tank wall.

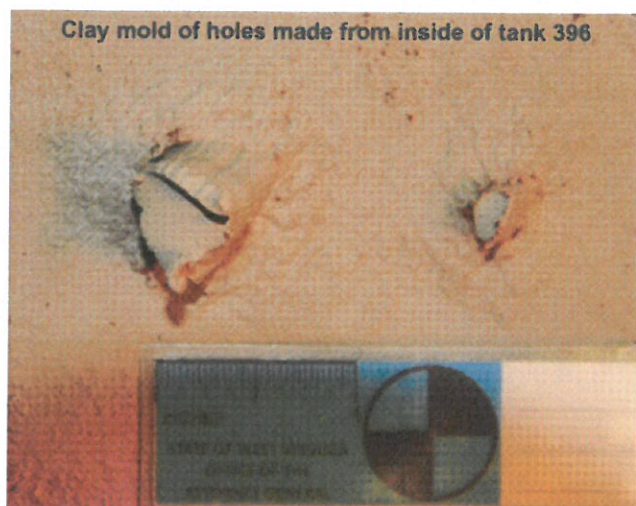
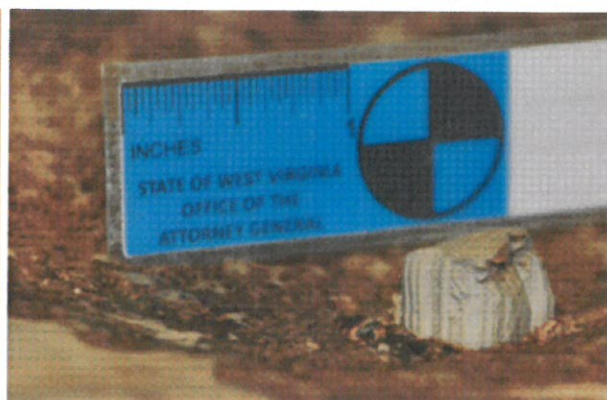
As part of its investigation, the WVAGO additionally obtained and produced clay moldings of the holes to document their respective size and shape.

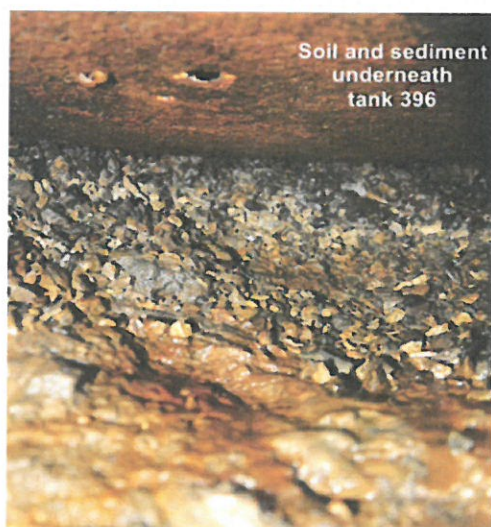
Both tanks 396 and 397 sat above a gravel/soil ground. There was a concrete pad that existed around the base of each tank, but did not extend underneath the tank.

The WVAGO investigation revealed that upon leaking from its respective ASTs, the MCHM chemical product leached into the gravel/soil immediately beneath it. The length of time for the leak is unknown, but based upon observations of corrosion around the holes and tank, the holes existed prior to January 9, 2014.¹³

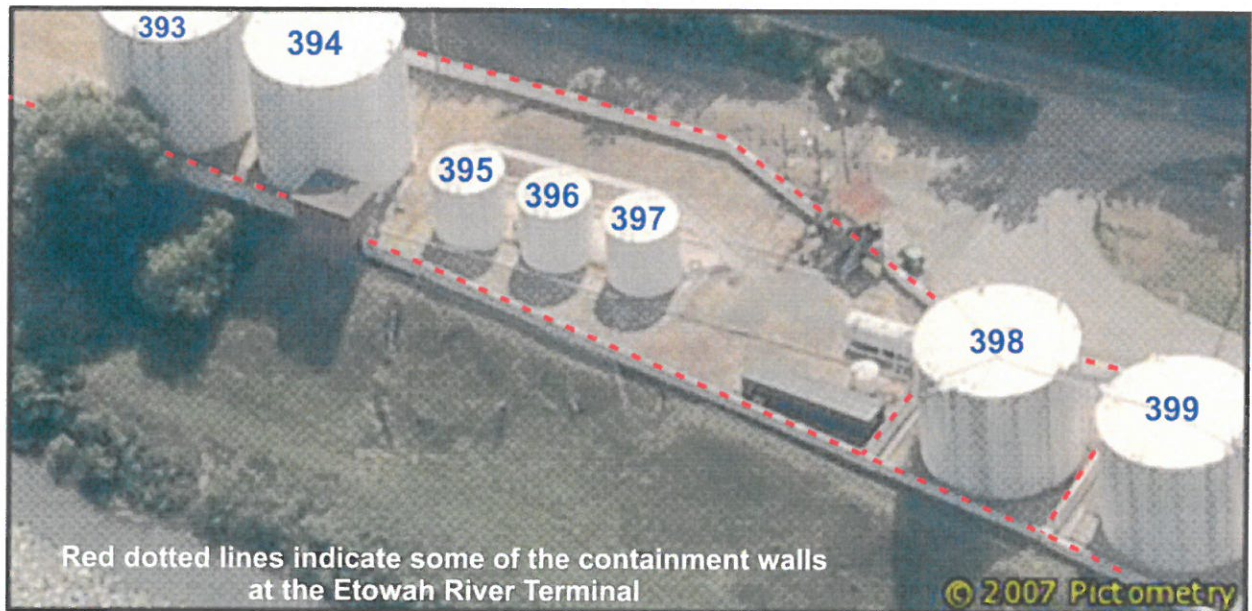
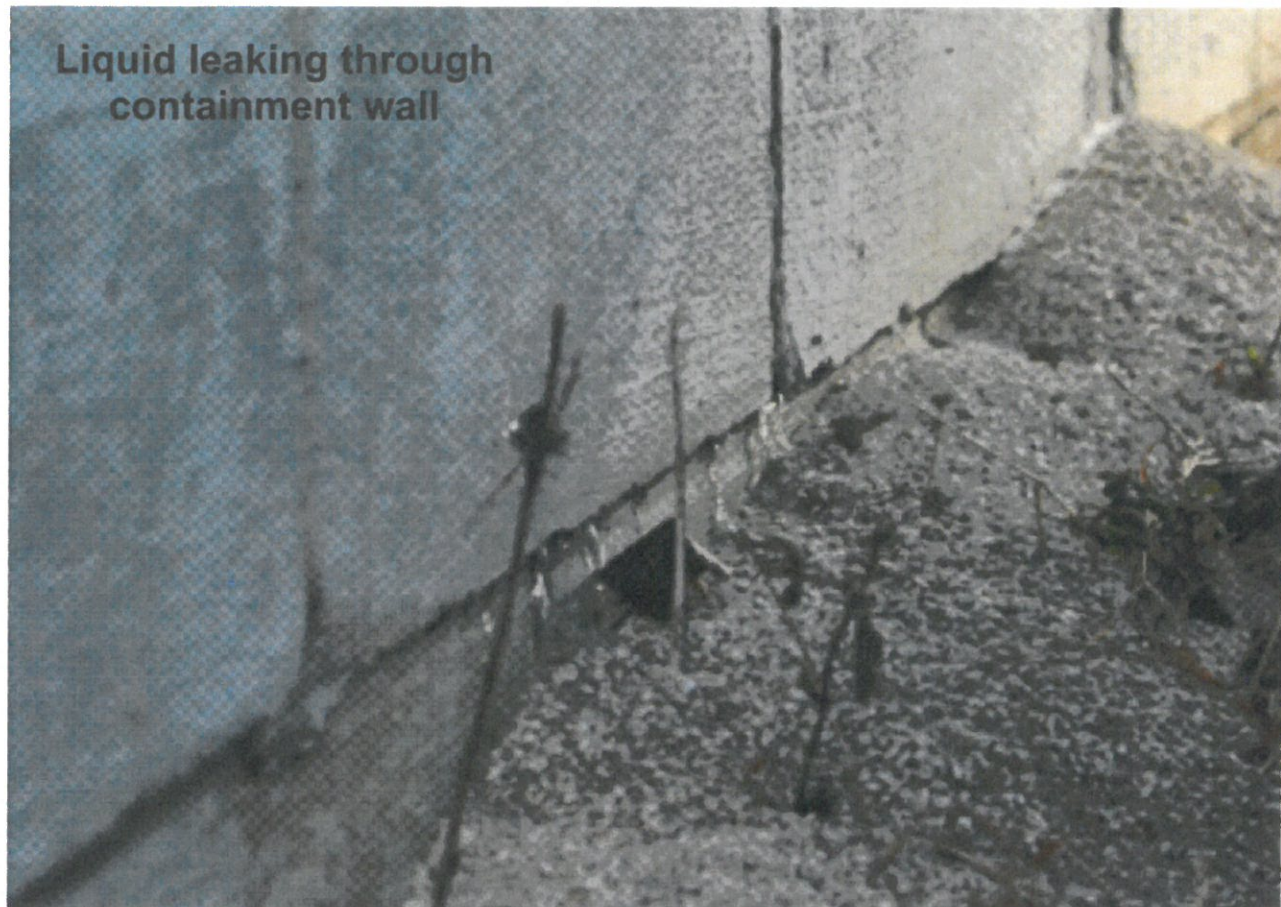
All ASTs were surrounded by a containment wall that extended the length of the property. This was to serve as a secondary containment system in case of a leak. The WVAGO investigation revealed that the containment wall failed and chemical product flowed both through and underneath the containment wall. In particular, the WVAGO was able to document frozen substances coming out of the wall several days after the event.

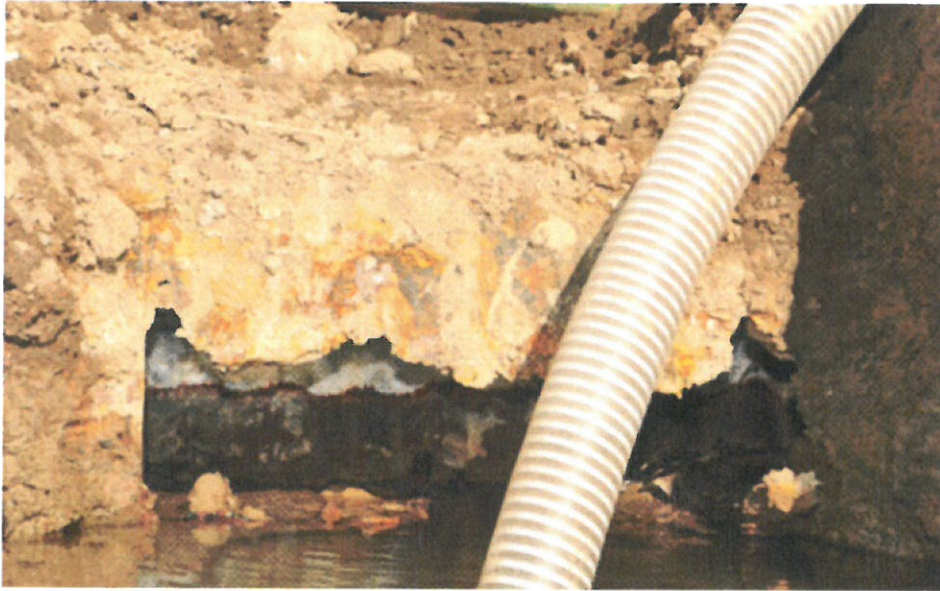
Second, a culvert running underneath the property became deteriorated and broken, thus facilitating the water flow into the Elk River. The WVAGO investigation indicates that the chemical product leaked into openings in the culvert and provided a more direct path into the Elk River.

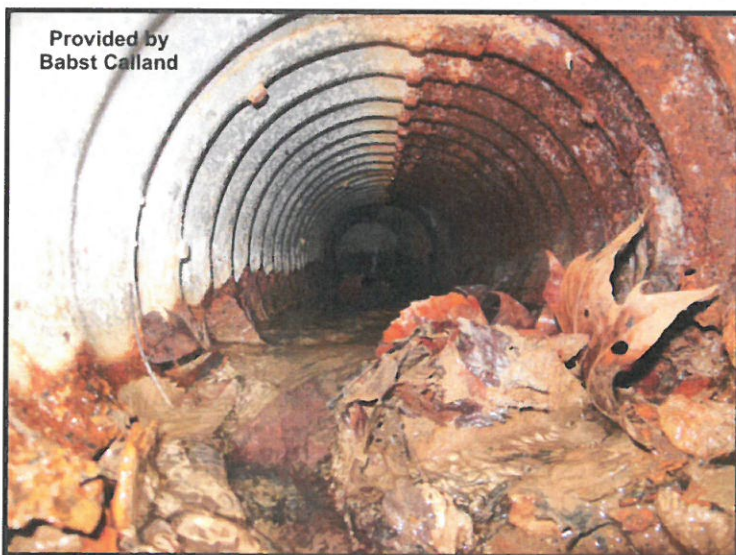
The property had other problems as well. For example, a metal culvert running underneath the tank farm designed to carry stormwater to the river corroded, allowing

water to make its own path or pathways under the facility property. This culvert traveled east to west under the facility in the area just north of tank 395. During the course of the investigation, contractors located, excavated and exposed a section of this culvert. In the area that was exposed, a large void could be seen in the south side of the

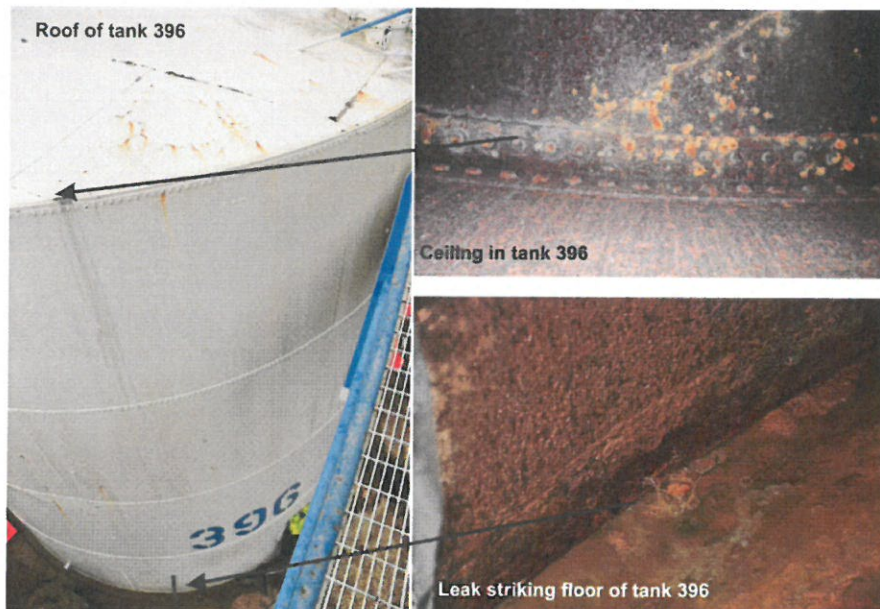
During the course of the investigation, the WVAGO photographed and documented the physical appearance of tank 396 and surrounding tanks. As reflected, in the photographs, the outside of tank 396 had flaking paint, rusting, and pitting. In addition, an inspection of the inside of the tank revealed neglect. First, the roof of the tank was leaking.

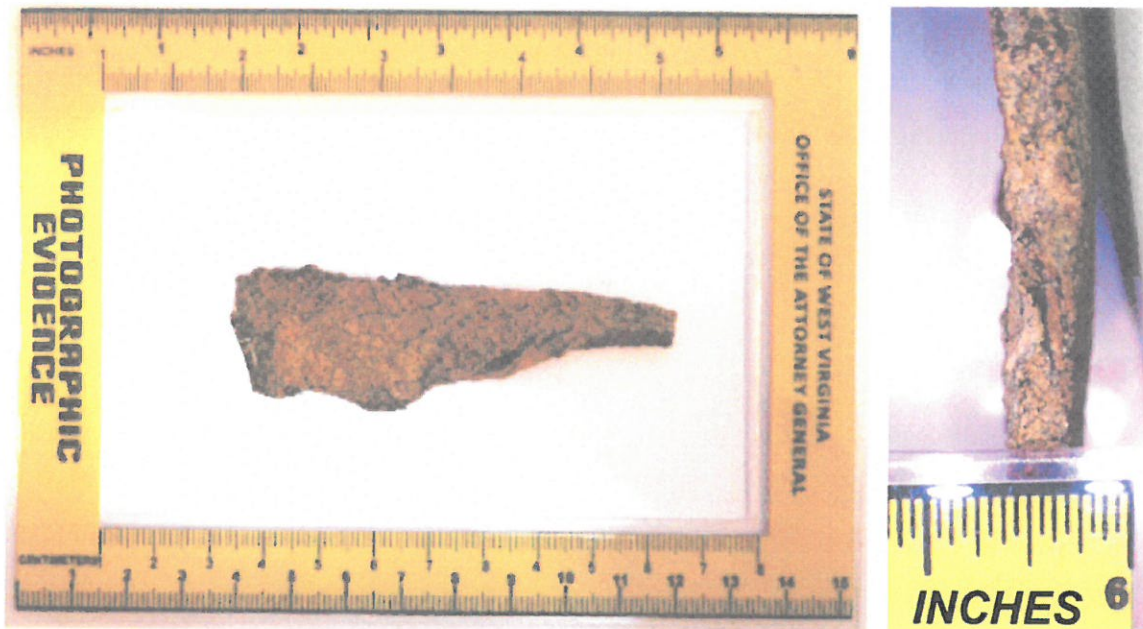
Second, a liner/patch was discovered in the bottom of the tank over the corrosion.

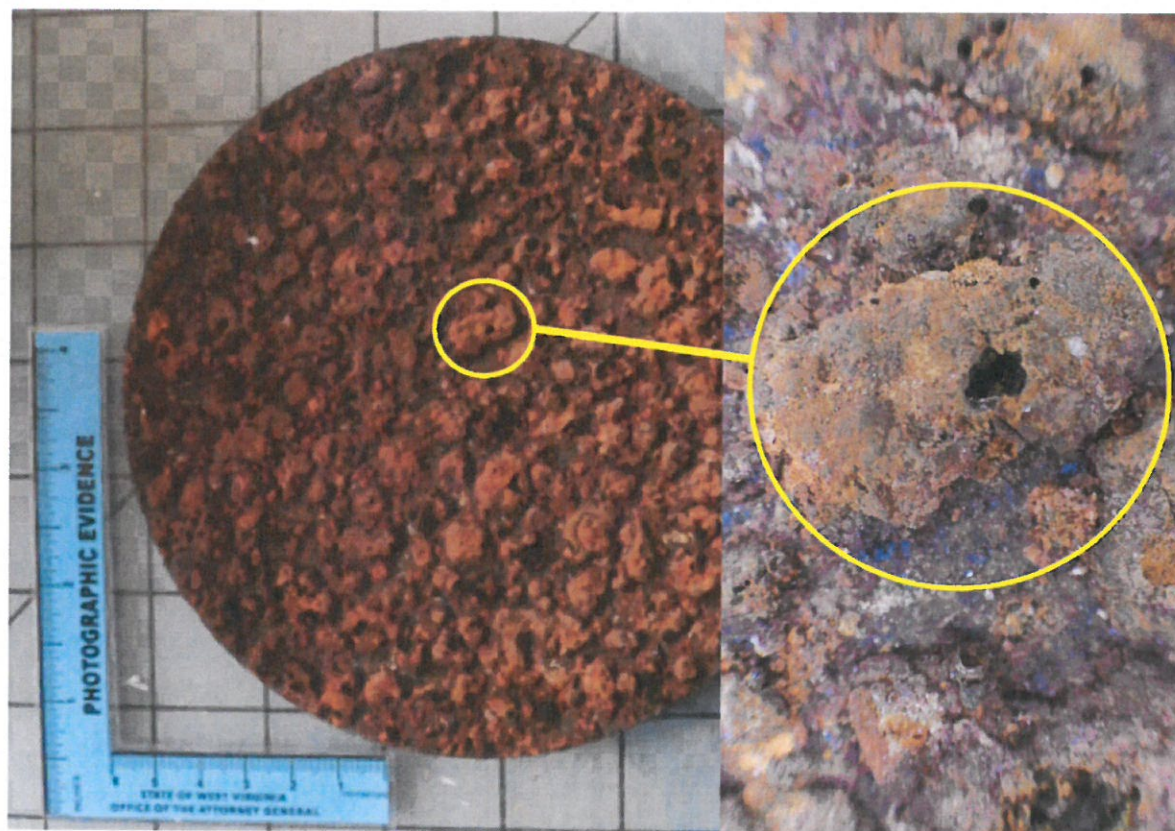
Third, signs of corrosion inside the tank were observed.

Corrosion on inside of coupon removed from side of tank 396

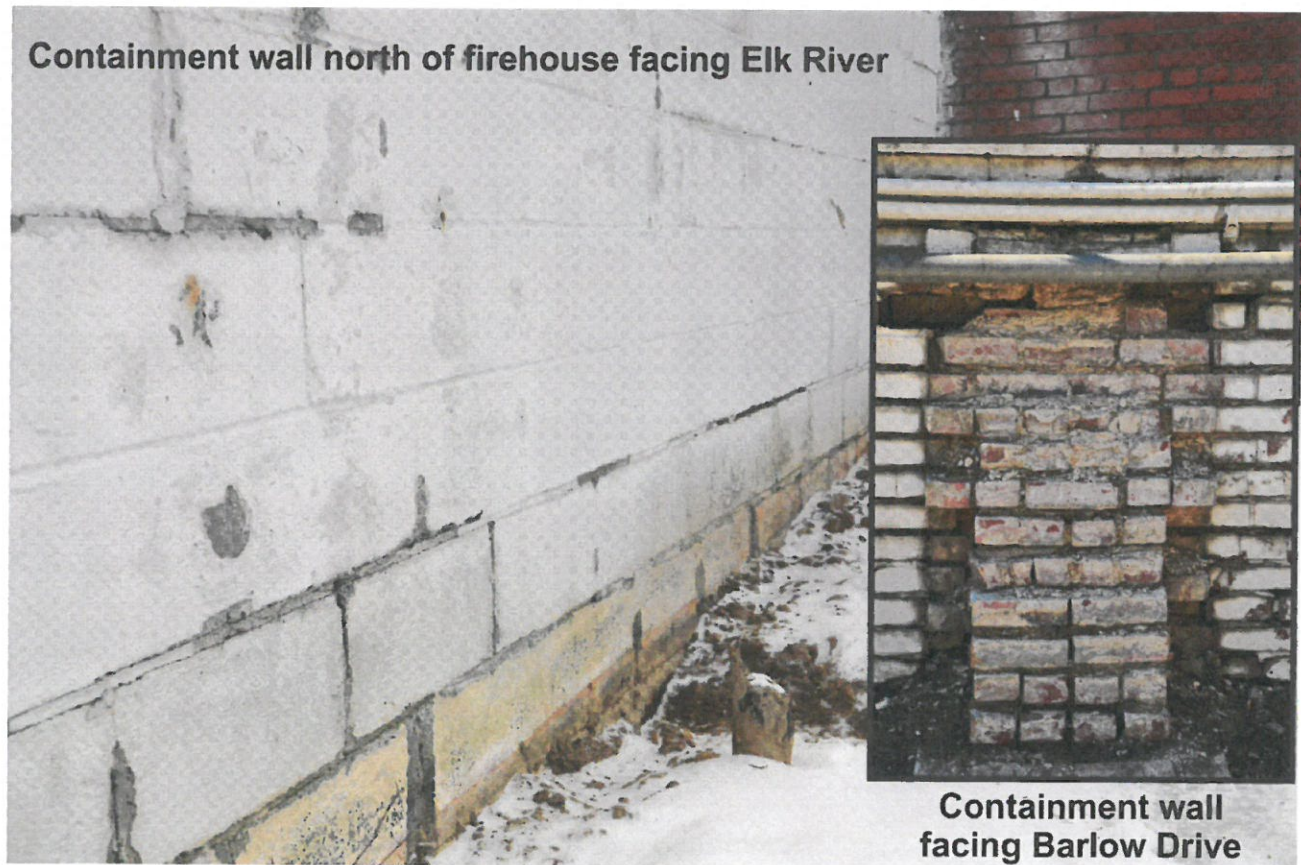
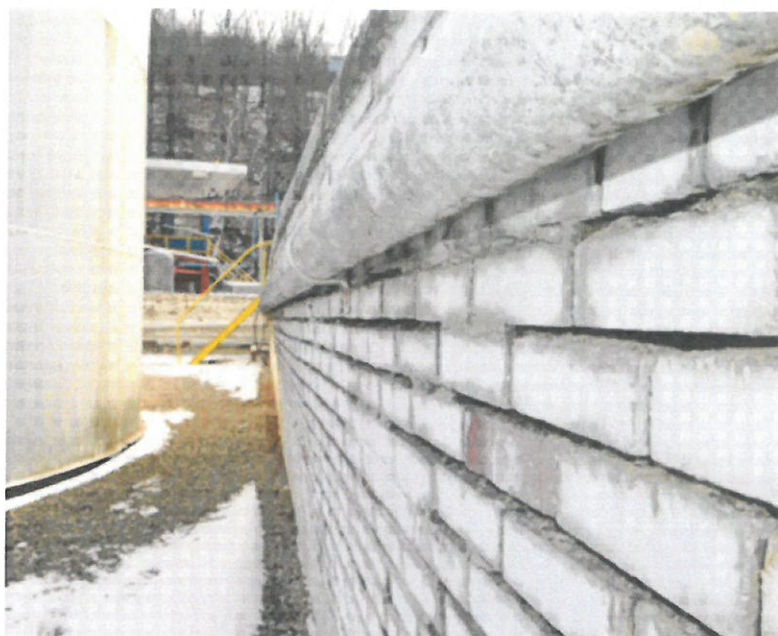
The purpose of the containment (dike) wall was to contain any spill or release of the product from the tanks. The walls, constructed of cinderblocks or bricks, had deteriorated to the point where bricks had broken apart or were completely missing. Cement mortar was missing from between the blocks in several areas.

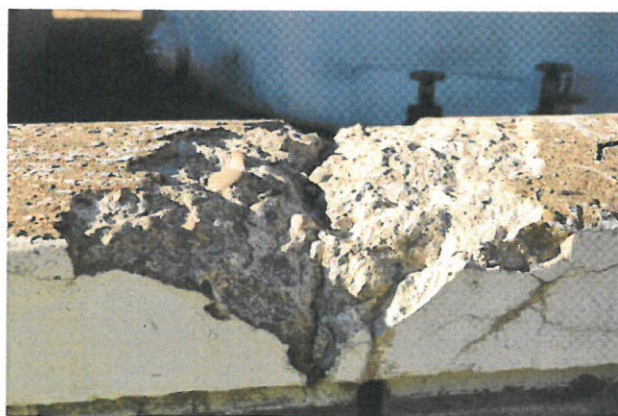
between the blocks and some of the mortar caps were missing. For example, in one section of the west containment wall, a large section of cap was missing, which exposed the open top of the cinderblocks and the hollow center. The deteriorated or missing cap allowed for the infiltration the elements, which further compromised the effectiveness of the dike walls.

Cap of brick containment wall facing Barlow Drive

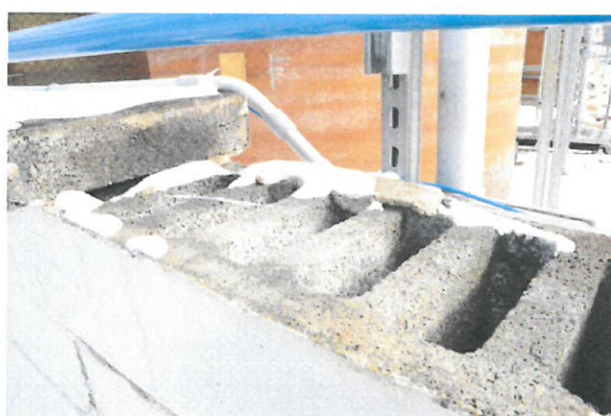
Missing cap on containment wall facing Elk River

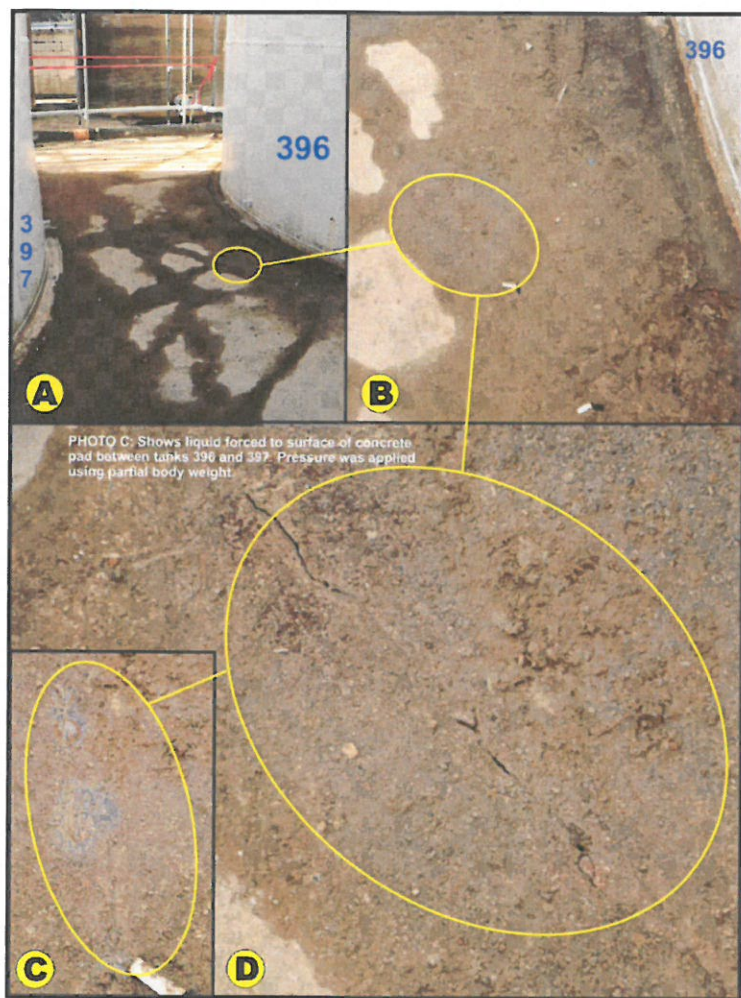
The WVAGO investigators also noted that the concrete pads sloped down toward the chime of the tanks. This slope allowed for the buildup of dirt, mud, and other debris, and for the pooling of water around the chimes of the tanks. The investigation did not determine if the slope of the concrete was a construction defect, or was caused by erosion and/or settlement of the ground beneath the tanks.

This concrete pad defect or settlement situation surrounded tanks 395, 396 and 397. It remains unknown to the investigators when precisely the concrete pad was

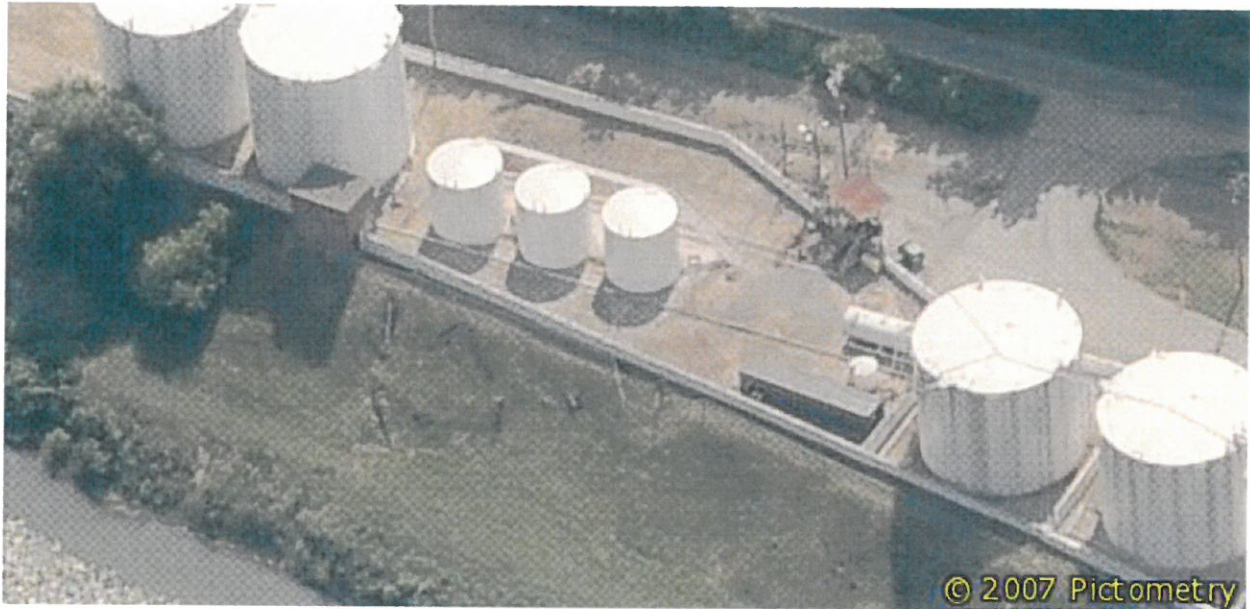
ground erosion on the embankment west of the dike wall near the fire house as the embankment travels towards the Elk River.

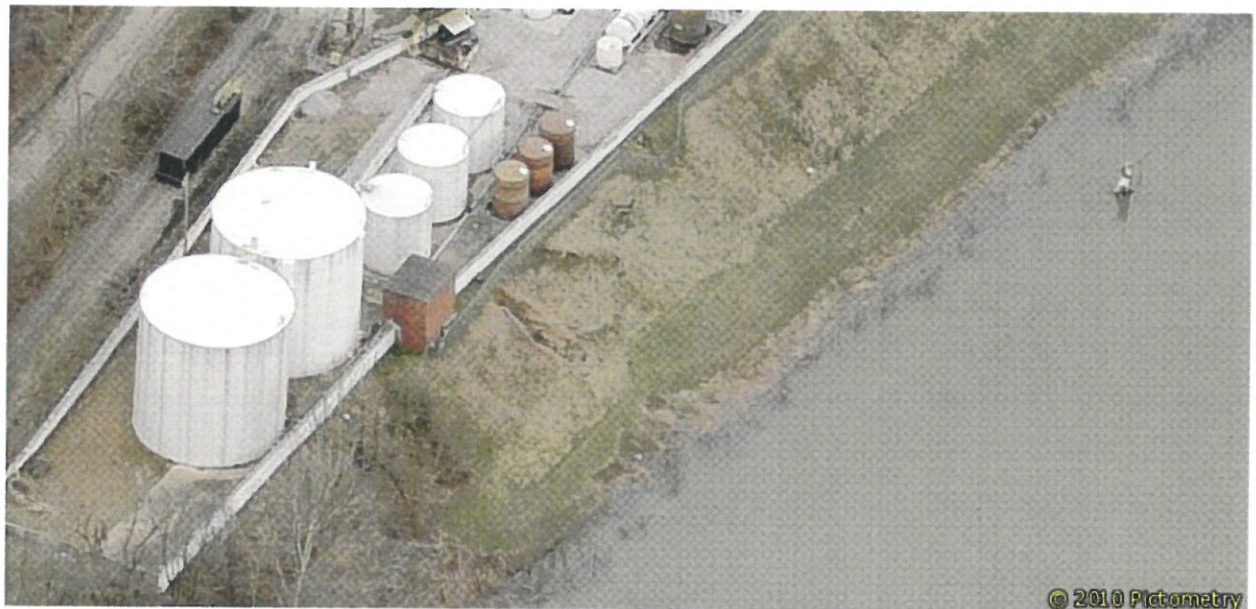
On March 10, 2010, Pictometry International Corporation again prepared aerial images showing the Etowah River Terminal. This image shows that the ground erosion documented on June 12, 2007, had continued and was considerably worse.

Company officials were aware of the erosion as evidenced in four (4) proposals made by Ryan Environmental Inc. on March 23, 2009, to control the river bank erosion.¹⁸ The erosion problem was not corrected and was still present when investigators arrived at the terminal on January 13, 2014.

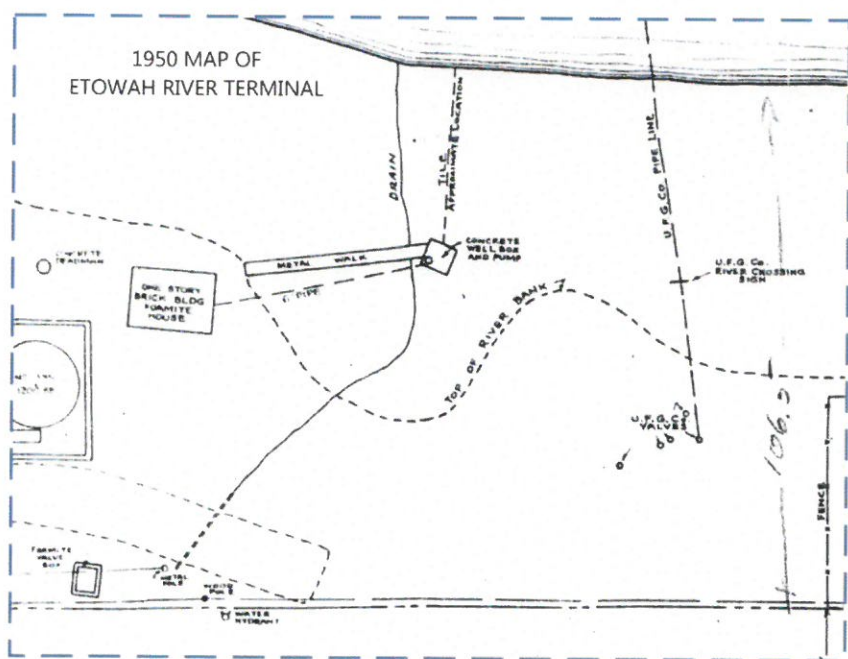
One of the most disturbing findings of this investigation was the fact that tanks 393 and 394 appear to be built partially on fill. A large portion of the ground on which the tanks rest was filled in prior to their installation. This is significant because much of the
